Lessons from a Dam Failure¹

ABSTRACT. The IVEX Dam (Chagrin River, northeastern Ohio) failed catastrophically on 13 August 1994, releasing 38,000 m³ (about 10 million gallons) of impounded water and sediment. This event was triggered by a 70-year rainfall event (13.54 cm of rainfall within 24-hours), resulting in flows 1.9 m above the top of the spillway and impinging on the top of the dam. The failure was the result of seepage piping at the toe of the dam, near the masonry spillway-earthen dam contact. Eyewitnesses reported that collapse of the seepage pipe created a breach in the dam that rapidly downcut. Paleohydrologic modeling suggests peak discharge through the breach was about 466 m³sec⁻¹, substantially dewatering the reservoir in approximately 2-3 minutes.

OHIO J SCI 100 (5):121-131, 2000

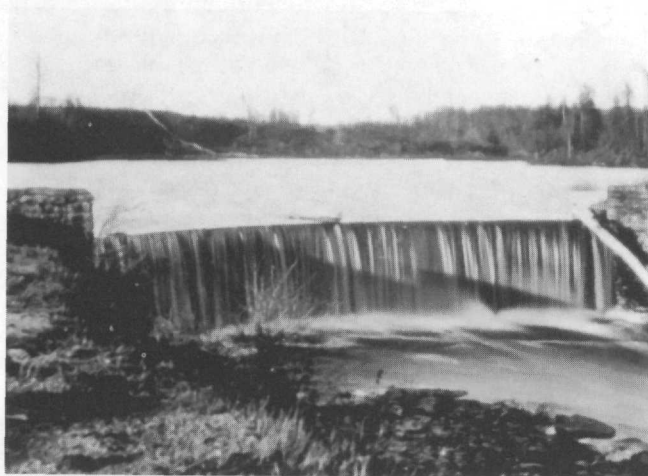
FIGURE 2. Oldest available photograph of the IVEX dam (about 1870) showing the masonry spillway attached to bedrock on the west bank (left) and the earth-fill dam on the east bank (right). Note absence of trees on the earth-fill dam. The spillway is 7.4 m tall. Photo courtesy of the Chagrin Falls Historical Society.

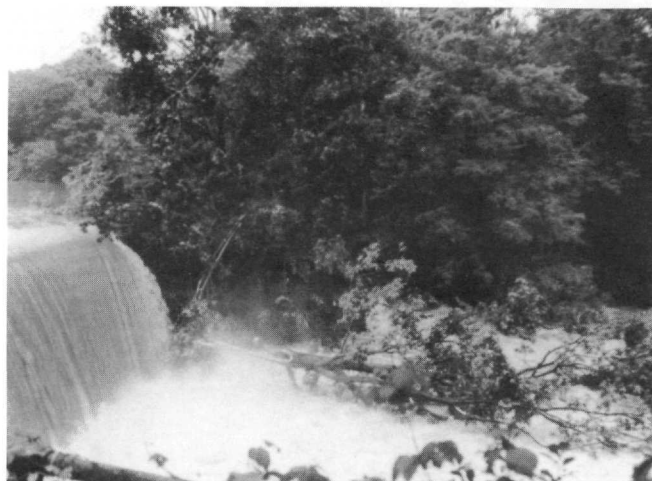
FIGURE 3. Photograph of the spillway of the IVEX dam minutes before failure of the dam at the spillway-dam contact (right). Note the growth of trees on the earth-fill dam. Also note presence of logs in the tailrace of the spillway. Photo courtesy of Y. Rausch, Chagrin Falls Historical Society.

the spillway, backing up flow and increasing stage height, at some critical time prior to failure.

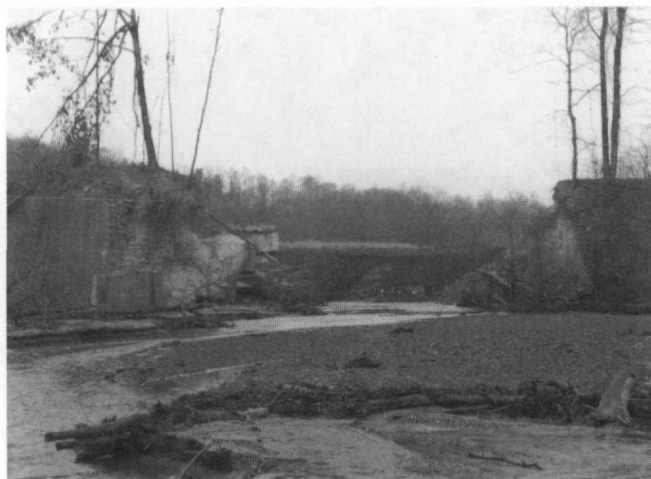
The IVEX failure resembled other seepage piping failures. Commonly, the result of seepage piping is eventual collapse of the pipe, leading to sudden collapse of a portion of the crest of the dam and formation of a breach (for example, MacDonald and Langridge-Monopolis 1984). The breach permits escape of the impounded water, which then downcuts to deepen and widen the breach, thus accelerating the flow rate. In this case, the breach formed near the contact of the masonry spillway and earth-fill dam (Fig. 4). This was the site of previous seepage piping problems, and the breach exposed the hydraulic patch used to repair the 1985 partial dam failure (Fig. 5).

FIGURE 4. Photograph of the breach in the dam taken days after the failure. Note the masonry spillway (left) and earth-fill dam (right). The hydraulic patch from the 1985 seepage piping failure is exposed on the left (west) side of the breach. Also note the reservoir sediments about 4.5 m thick just behind the spillway.

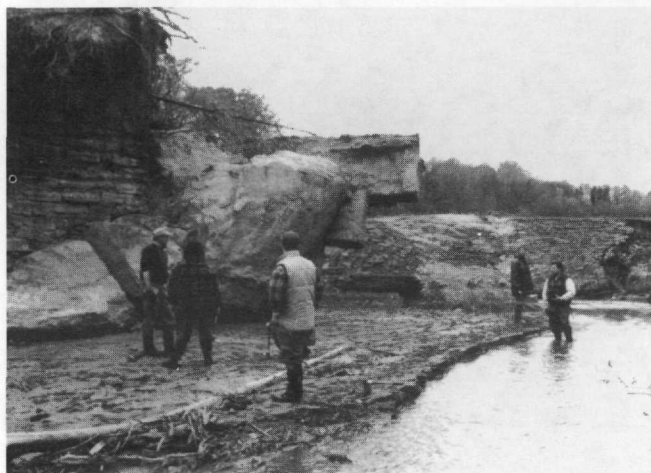
FIGURE 5. Close-up of the breach, showing the 1985 hydraulic patch and plug. Note gullying in the exposed reservoir sediments to the right background.

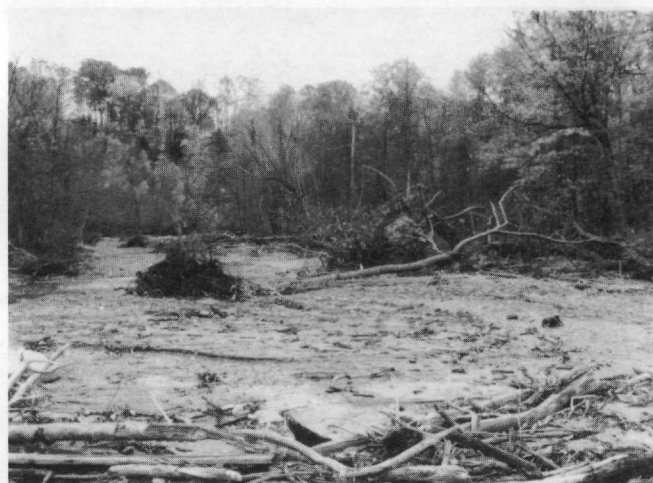
Downstream effects due to the dam failure included flooding, hydraulic damage (erosion), and sedimentation. Immediately downstream of the breach was a wide debris fan (Fig. 6) that extended over 1 km downstream into the reservoir of the Lower Mill Pond. Flood debris suggested that the height of the floodwave was approximately 1.5 m above bankfull depth (about 0.5 m), at a point about 200 m downstream of the spillway. The floodwave crossed the Lower Mill Pond (note, the entire length of this dam is a masonry spillway), and continued downstream. Extensive erosional damage was done to stream banks and culverts, and the causeway of the State Route 87 was inundated at a point about 7.0 km downstream of the breach. Note that most of the damage (for example, streambank erosion and deposition) is not easily quantifiable.

FIGURE 6. View downstream from the IVEX dam showing the debris-fan, bank erosion, and undercutting of mature trees resulting from the dam failure. The Chagrin River meanders to the right in this photo, and the flow crossed old chute channels on that point bar surface.

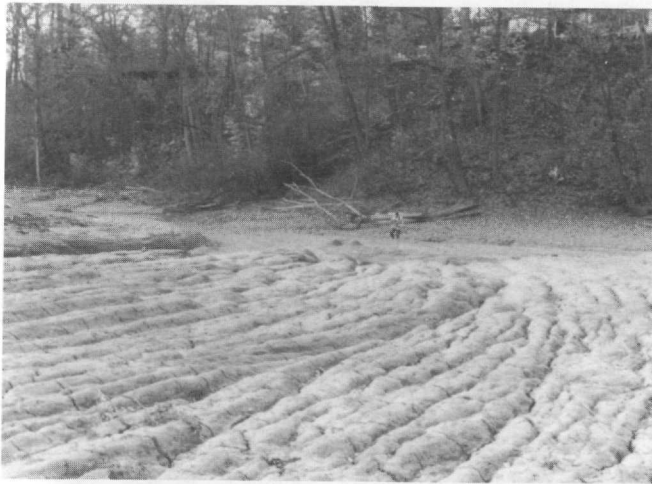
Flood effects within the IVEX reservoir include erosion that occurred during the dam failure (Fig. 7), de-

FIGURE 7. View of longitudinal scours produced in the reservoir due to escaping floodwaters after the dam breach. Person for scale (center background).

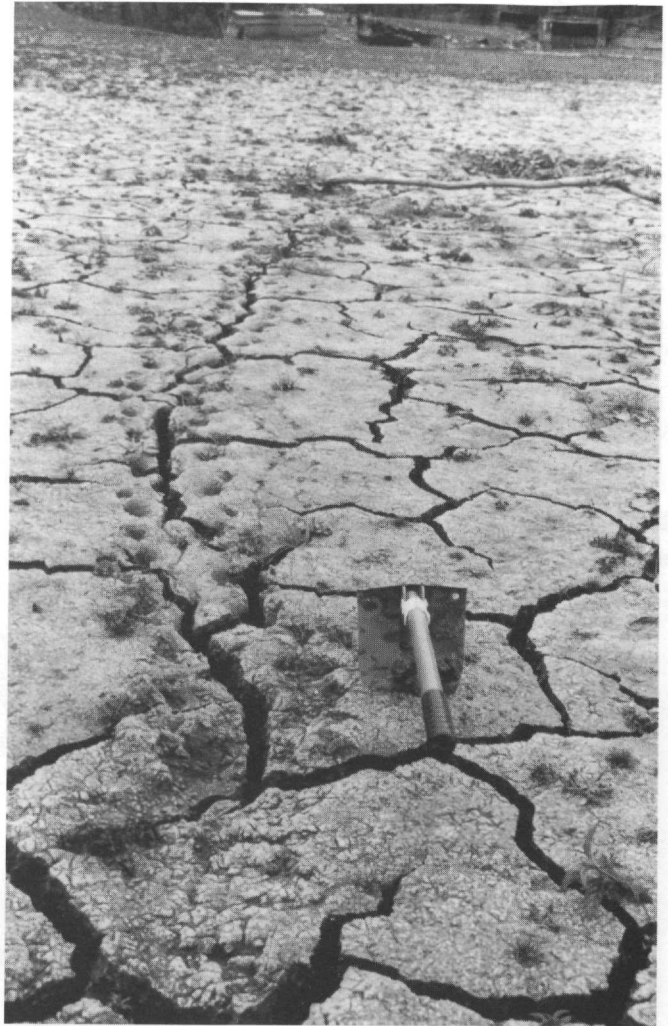
FIGURE 8. Compaction and desiccation of the fine-grained reservoir sediments following the dewatering of the reservoir. Shovel is 45 cm long.

watering and subsidence of the muddy reservoir fill (Fig. 8), and slumping of the poorly consolidated reservoir sediments into the new channel of the Chagrin River (Fig. 9). Incision exposed bedrock cutbanks of the pre-reservoir channel (Fig. 10), white cedar stumps from the pre-1842 floodplain (Fig. 11), the upstream delta infilling the reservoir (Fig. 12), and examples of rhythmically-bedded, fining-upward sequences representing sequential floods over the interval 1842-1994 (Fig. 13). Core data could be used to identify specific flood horizons (Fig. 14), and calculate changes in sediment accumulation rates that occurred in the reservoir. These sedimentation rates, and corresponding changes in land-use and sediment conveyance within the drainage basin, are discussed in detail in Evans and others (2000a).

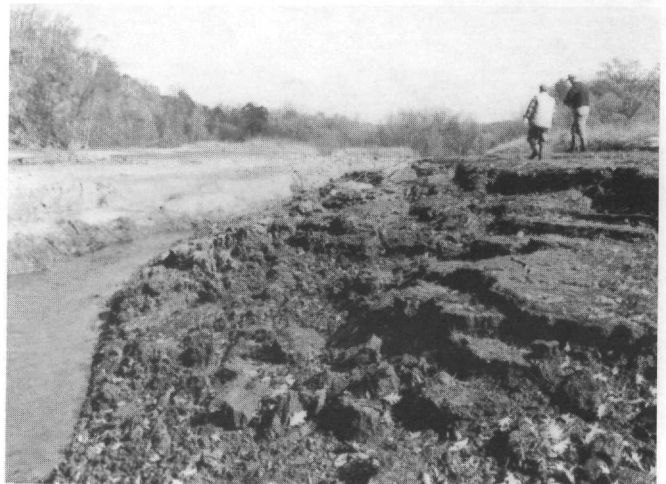
FIGURE 9. Significant slumping of the water-saturated reservoir sediments into the newly incised channel of the Chagrin River as it adjusts to breaching of the dam and changes in longitudinal profile.

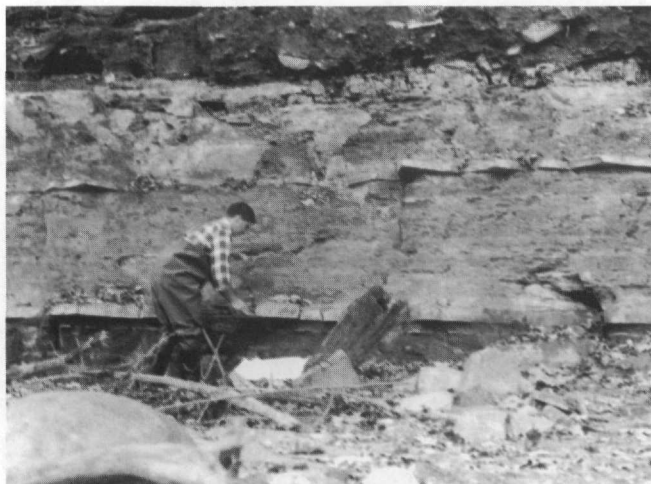
FIGURE 10. Bedrock outcrop exposed due to incision of the Chagrin River following breaching of the dam. This outcrop represents a bedrock valley wall of the pre-reservoir channel, being exhumed by recent incision.
